QUICK REPORT ON THE SEPTEMBER 26, 2003 TOKACHI-OKI EARTHQUAKE, JAPAN

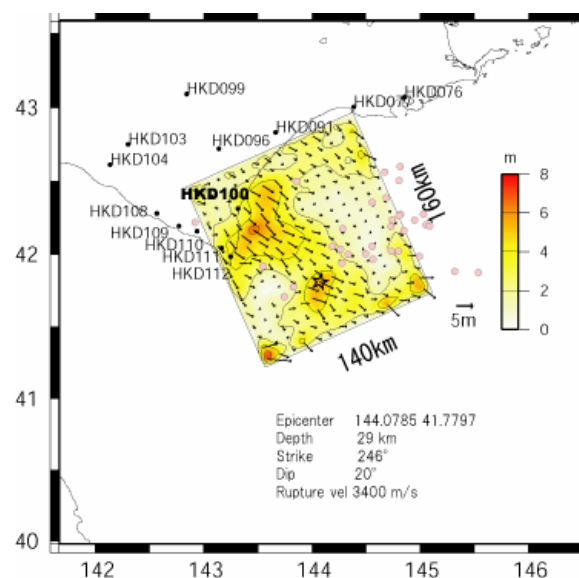
Figure 1 shows the estimated total slip distribution, which consists of two major slip areas; (a) around epicenter and (b) the north-west part of the fault with the maximum slip of 7.1 m. Relatively small slip velocity (~ 0.75 m/s) and long slip duration (nearly 13 sec) are obtained at region (a). This corresponds to the fact that onsets of direct waves were obscure in many observed seismograms.

Figure 1 Estimated slip distribution on the fault plane. Colored circles are thrust type aftershocks. The star shows the epicenter. Arrows indicate the amplitude and direction of slip.

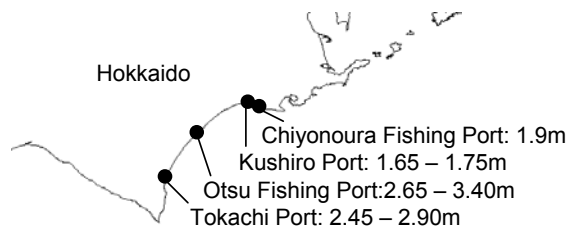
The Tokachi-oki Earthquake in 2003 generated a series of tsunamis. The main shock occurred at 4:50 (JST) on 26 September. The tsunamis were observed on the Pacific coasts from Hokkaido to the Tohoku region in Japan. Many researchers including members of PARI conducted tsunami field survey started at the same day, when the main shock occurred. The highest evidence of tsunami run-up was found at Cape Erimo and it was 4.0m. The tsunami height of 2.5m was observed at the tide station in the Tokachi Port at 5:24 (JST) about 30 minutes after the main shock. After the tsunamis arrived at the coasts in Hokkaido, they propagated along the coasts like edge waves and a number of tsunami attacked the coasts. At the Kushiro Port, the first tsunami of 1m arrived at 5:06 (JST), the maximum tsunami of 1.2m observed at 9:03 (JST) and a 1m tsunami attacked again at 14:20 (JST). At that time tsunami inundation occurred because the tsunami added to the normal high tide and the resultant sea level became high. At the Tokachi River, the tsunamis ran up 11km from the river mouth.

Figure 2 Tsunami run-up measured by PARI

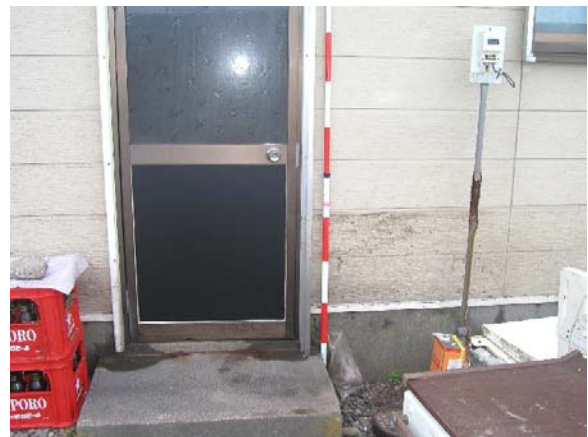
Photo 1 Evidence of tsunami run-up at Tokachi Port

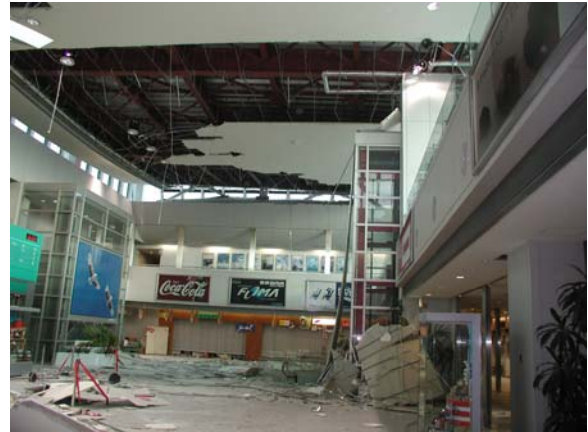
The three edges (north, south and east) of the ceiling were separated from surrounding structural elements and only the west edge was rigidly connected to the structure. Due to the pounding of the ceiling to the west structural frame, a large area of the ceiling fell down. No one was injured due to the early morning shock.

Photo 3 Damaged ceiling

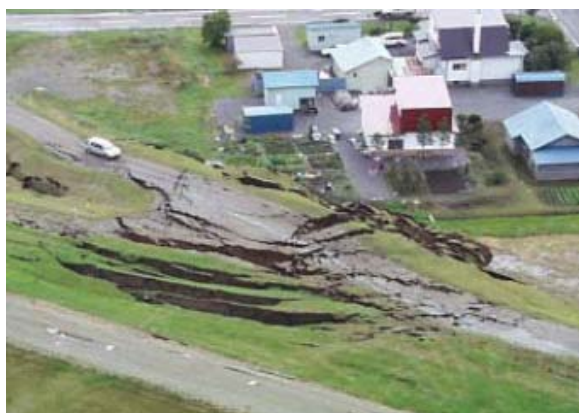
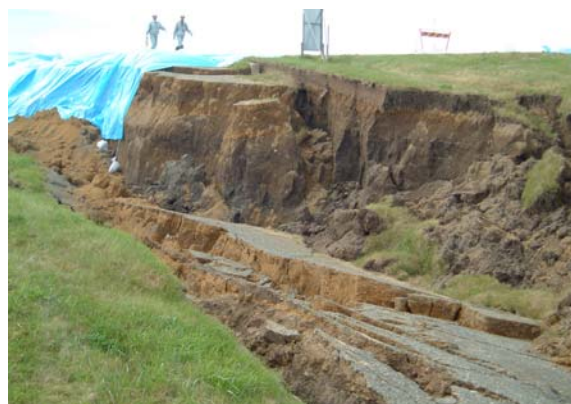
River dikes in Obihiro area including Tokachi river, Urahoro-Tokachi river and Usikubibetsu river were severely damaged during the earthquake. The total length of the damaged dike adds up to more than 25 km. Typical layout of the dikes in the area, particularly for the dikes of Tokachi river, has geometry of 5-10 m wide crest, 4-8 m height and gentle slope angle of 1:5. The observed damage to the dikes is mostly longitudinal crack and settlement of crests and lateral spreading of the gentle slopes as shown in Photo 4. The similar damage to the dikes in this particular area was observed during the 1993 Kushiro-oki earthquake.

In this area, extremely soft peat soil prevails the ground surface and ground water table are close to the ground surface. The dikes in this area, which were constructed using sandy soils, have significantly settled, causing the base of the dikes penetrated into the foundation soil. The mechanism and the main cause of the damage to the dikes is presumed to be liquefaction of the dike material below the ground water table, which is similar to that during the 1993 event.

Photo 4 Collapse of slope of Tokachi river dike (right bank, 3.5 km from river mouth)

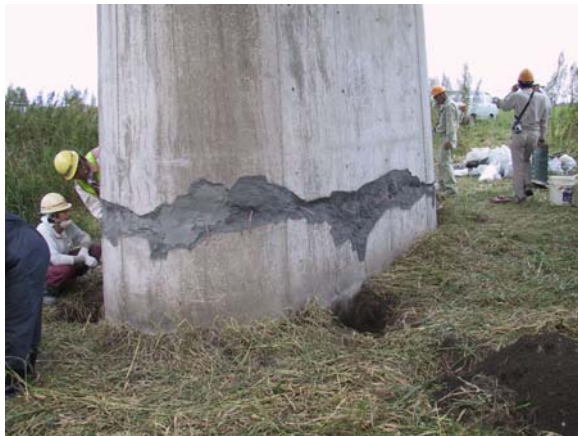
Chiyoda Bridge (Photo 5)

Chiyoda bridge was constructed in 1966 and has 15-span simply-supported girder/truss bridge with total length of 706m. The substructures are wall-type RC columns. The damage was developed at the mid-height sections of RC columns where some of the longitudinal reinforcement is terminated. Photo 5 shows the damage of Pier #13 in which the heaviest damage was found. The cover concrete was spalled-off, and some of the longitudinal reinforcement was buckled at the section. The columns was repaired and strengthened by concrete injection and steel jacketing.

Photo 5 Damage of wall-type reinforced concrete columns (Chiyoda Bridge. Spall-off of cover concrete was repaired by concrete injection.)

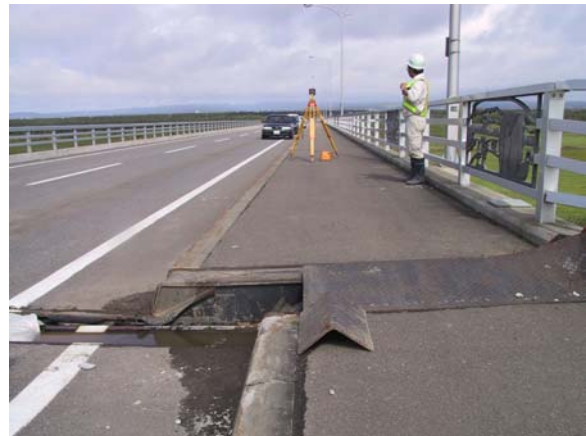
Tokachi River Bridge (Photo 6)

Tokachi river bridge with total length of 926m was completed in 1992. The bridge consists of 3 superstructures with 3-span continuous PC box girders and 3-span PC frame bridge. The substructures consist of wall-type RC columns and pile foundations. The bridge is located close to the fault zone where very strong ground motion was observed. The bearings were failed and the residual displacement of about 70cm in the transverse direction was developed at the continuous box girders as shown in Photo 6. Damage to substructures was not found.

Photo 6 Damage of bearings and transverse residual displacement of deck (about 70cm) (Tokachi River Bridge)

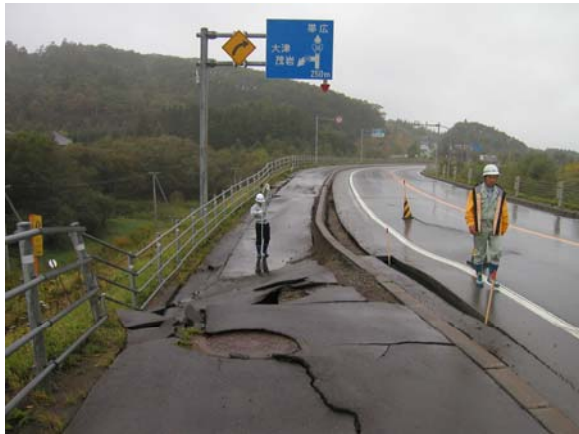
This part of the highway is an approximately 10m high embankment that connects with the dike of Tokachi River. A longitudinal crack was observed on the slope of embankment, and the road surface was settled over approximately 15m long (Photo 7).

Photo 7 Approach of Toyokoro Bridge, National Highway Route 38 (Photo by Hokkaido Development Bureau)

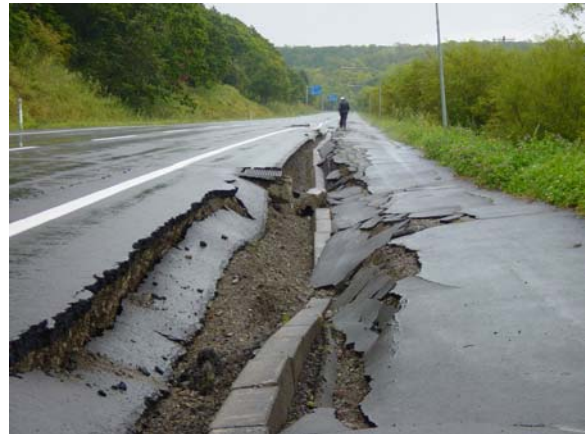
This portion of the highway is a half-bank and half-cut. The valley-side of embankment is a swamp, and the groundwater level seemed to be high. The sidewalk was collapsed over more than 100m and the roadway was partially damaged (Photo 8).

Photo 8 Chobushi, National Highway Route 336

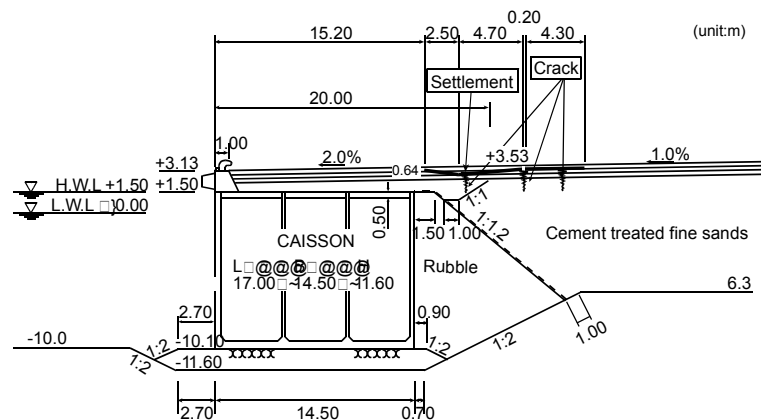
The major damage of port facilities during the 2003 Tokachi-oki Earthquake is No.4 pier caisson type quay wall (-10m, $k=0.2$) of Kushiro port moved toward sea 10cm to 20cm and large settlement (roughly 0.5m) of apron occurred as shown in Figure 3. The reclaimed material is cement treated dredged fine sands (SPT $N=10$), the PGA at Kushiro port were 575 Gal in EW, 347 Gal in NS and 149 in UD respectively. The key point of the damage mechanism is behavior of backfill rubbles and cement treated soils during the earthquake as follows, 1) the confining pressure of backfill rubbles should be suddenly decreased due to movement of the caisson, 2) then re-arrangement of rubble particles occurred, 3) cement treated fine sands could not follow the deformation of backfill rubbles, 4) large settlement occurred just

behind the caisson body.

Figure 3 Cross section of -10m caisson type quay wall at Kushiro port No.4 pier

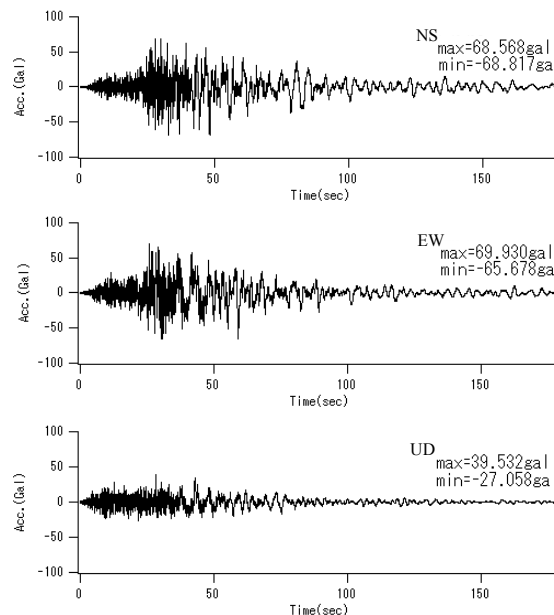
During the earthquake, Tomakomai Port was shaken with 70 Gal in EW, 69 Gal in NS and 40 Gal in UD respectively, long period component of 5-8 second and around 180 seconds duration as shown in Figure 4. The cylindrical oil tank (a diameter of 43m, oil depth of 18m and the natural period of first mode of sloshing is 7.1 sec) having floating roof burned due to the earthquake. From the results of back analysis of tank during the earthquake, the maximum uplift of the floating roof occurred 3m at 48sec in EW and 2.3m at 80sec in NS respectively.

Figure 4 Strong motion records at Tomakomai port during 2003 Tokachi-oki Earthquake

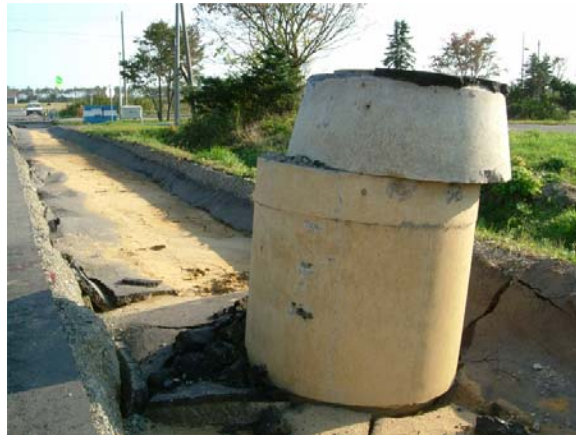
Sewer facilities in Obihiro area and Kushiro area were severely damaged during the earthquake. The amount of damage to sewer facilities is up to 5 billion yen. The observed damage to the sewer facilities is

mostly uplift of pipes and manholes and settlement of road surface above the damaged pipes as shown in Photo 9. The damaged pipes were constructed by the open-cut method, in which sandy soils were used for backfill. The similar damage to the sewer pipes in Kushiro city and Kushiro town was observed during the 1993 Kushiro-oki earthquake and the 1994 Hokkaido-Toho-Oki earthquake. The most of the damaged pipes were located in wetland, where extremely soft peat soil prevails the ground surface and the ground water levels are shallow. Liquefaction of the backfill soil blow the ground water level was considered to be a major cause of the damage, while amplification of the ground motion at the peat layer was considered to affect the extent of the liquefaction of backfill soil.

Photo 9 Ejected manhole and settlement of road surface
